Manufacturing and impact behaviour of aeronautic overmolded grid-stiffened thermoplastic carbon plates

F. Neveu, C. Cornu, P. Olivier, Bruno Castanié. Manufacturing and impact behaviour of aeronautic overmolded grid-stiffened thermoplastic carbon plates. *Composite Structures*, 2022, 284, pp.115228. 10.1016/j.compstruct.2022.115228 . hal-04108752

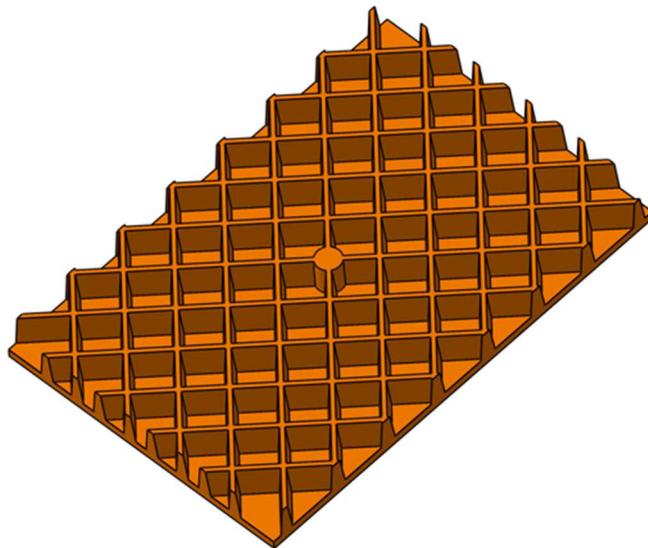
Figure 1. General shape of the specimens to be manufactured.

The objective of the work presented here was first to obtain a stiffened specimen having the general shape given in Figure 1. So the important manufacturing issues encountered are shown. As the problem of low speed impact, low energy is the main sizing criterion [11] for aeronautical structures, the overmolded parts were impacted and the damage patterns are analysed here. The specimens have dimensions of 100 mm x 150 mm, which correspond to the standards for impact and post-impact compression tests in the aeronautical industry ([11], Airbus AITM 1-0010 standard). First, the possible

The objective was to obtain specimens with dimensions of 100 mm x 150 mm (Figure 1) with an overmolding forming a grid either at 90° or at 45°. After several design iterations, in order to simplify the mold, a larger plate (220 mm x 220 mm) was injected and then cut to obtain the desired shape (Figure 8). There were 4 possible configurations depending on whether the center of the plate on which the impact would take place was located on a corner of the grid or at the bottom of the mesh, at 0° or at 45°.

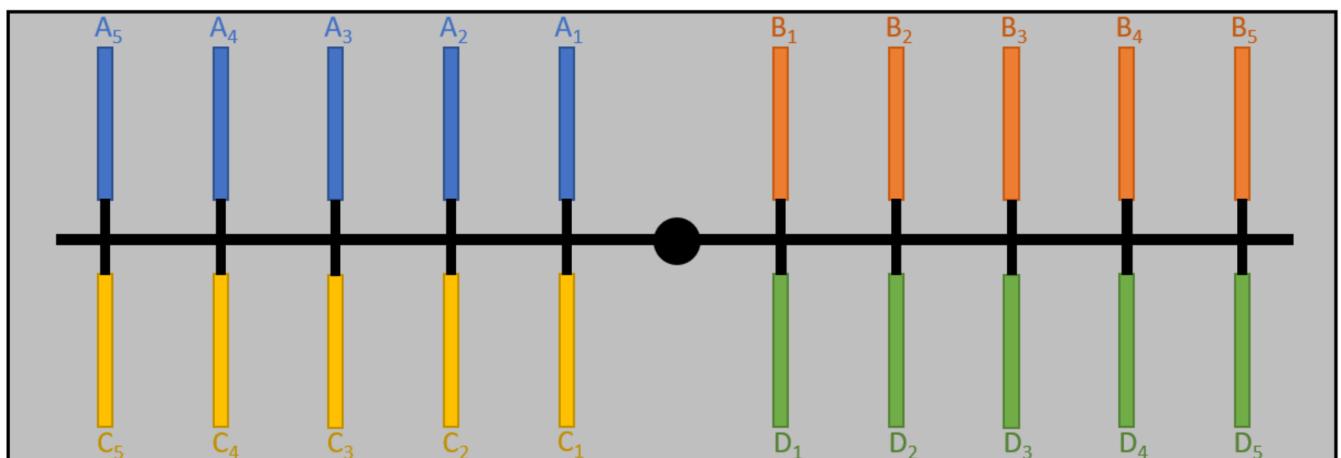
Figure 2. Arrangement of the overmolded tabs.

To determine the mechanical strength of the overmolding, a conventional test mold with tabs, belonging to CETIM, was used for pull-out and unfolding tests. The CETIM mold makes it possible to manufacture composite plates comprising twenty overmolded tabs distributed in four rows of five pieces, as illustrated in Figure. 2. A finished plate is shown in Figure. 3. The injection point is located in the center of the space and the filling is therefore symmetrical (or almost, because each row has a rib foot of different design). The position of each tab relative to the injection site was noted in order to assess whether this factor had any influence on the results.

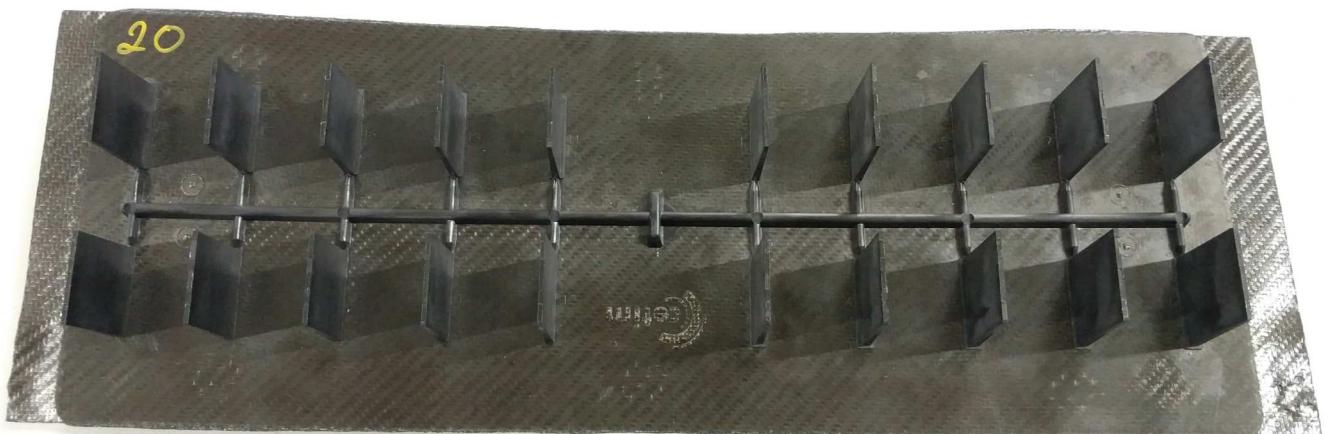
Figure 3. Plate after manufacturing.

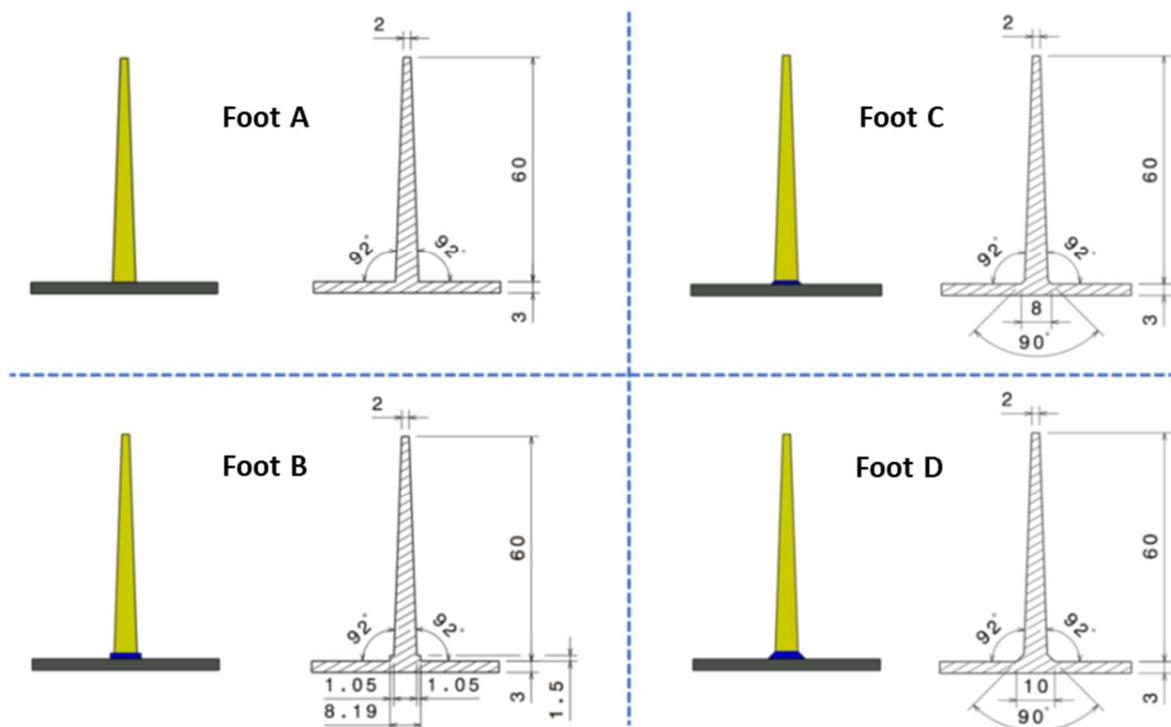
The designs of the 4 types of feet are shown in Figure 4:

Without foot (from A1 to A5)

With foot in the form of a "step" (from B1 to B5)

With foot in the form of a small chamfer (from C1 to C5)

With foot in the form of a large chamfer (from D1 to D5)

Figure 4. The four designs of the feet of the overmolded tabs.

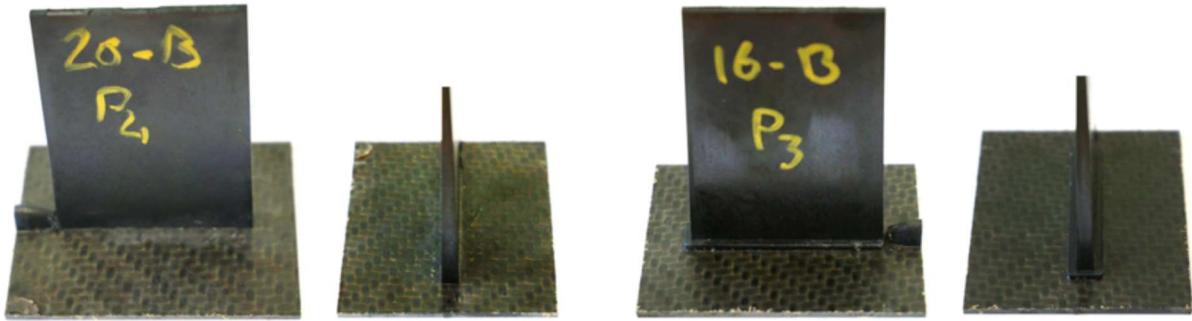
Figure 5. Pictures of the tab specimens (Type A, left; Type B, Right)

The twenty specimens per plate were cut on a water jet cutting machine. It should be noted that, despite the precautions taken, some specimens were lost during cutting, which explains some missing samples in the test matrix (Table 1). The specimens obtained after the cutting operations had final dimensions of 60 mm x 50 mm. An overview of these specimens is given in Figure 5. These specimens were used directly on their respective assemblies; only slight retouching was needed when the resin supply channel visible on the side of the tabs was removed.

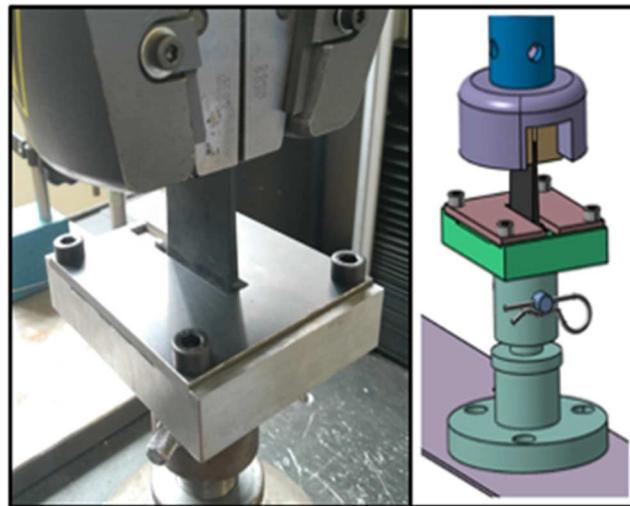
An Instron 10 kN type tensile machine was used for the tests because its maximum force is low and the measurement error is minimized. Specific devices were designed for the tab specimens in the two pull-out and unfolding tests. The pull-out test was a simple tensile test in which the jaw of the machine was caught on the tabs. The base of the specimen was kept fixed by the addition of a retaining plate that was screwed over the base of the assembly (Figure 6).

Figure 6. Pull-out (left) and unfolding (right) test setups.

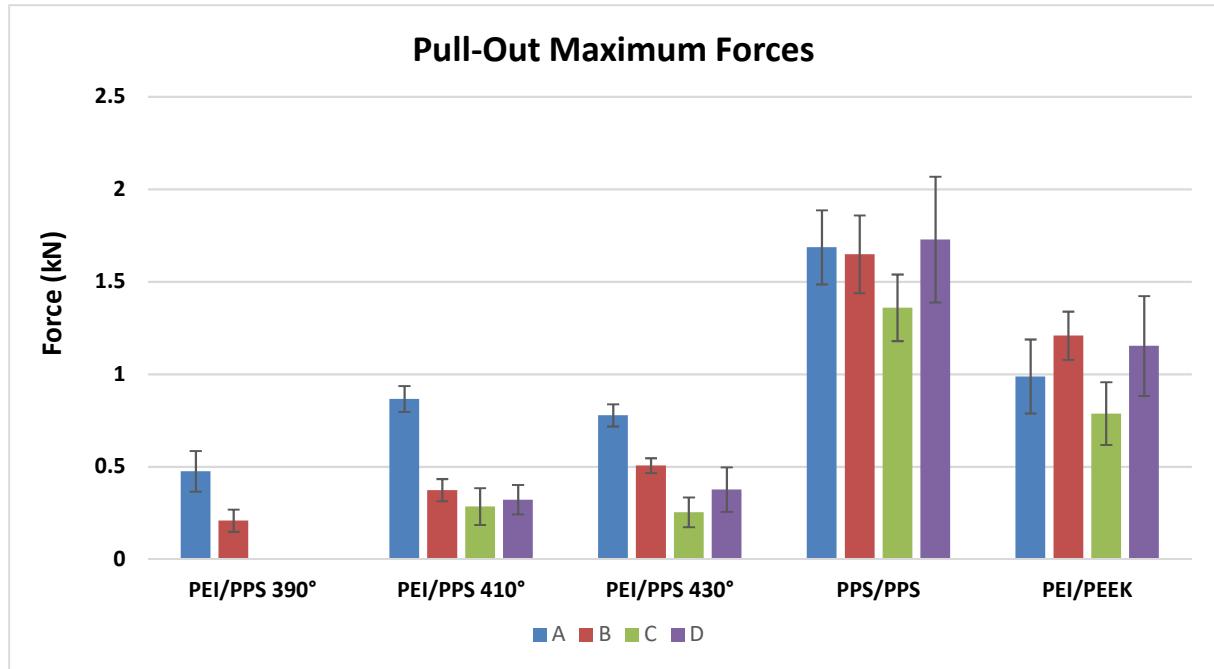
Figure 7. Summary of maximum forces for pull-out tests with standard deviation.

The tables show no clear influence of the injection position from 1 to 5 unlike in [21]. In order to have a more graphic representation of these results, a histogram comparing the mean values of the forces at failure is proposed in Figure 7, with the margins of error representing the maximum and minimum values of each series. In general, there is a large dispersion for this type of test. There is also a great disparity in the results between the three pairs of materials. The tests clearly show the low resistance of the PEI / PPS pair compared to the PPS / PPS or PEI / PEEK pairs. It is the PPS / PPS pair that offers the best adhesion, which is logical because the overmolding and the plate are of the same nature. Although the design of the rib foot seems to have a certain influence in the case of the PEI / PPS pair, the disparities are less for the other two (if we exclude the type C design, which gives the lowest breaking forces in all cases). For the PEI/PPS pair, it shows clearly that a minimum injection temperature is required to have an efficient bonding strength which would be more likely at least around 410°C.

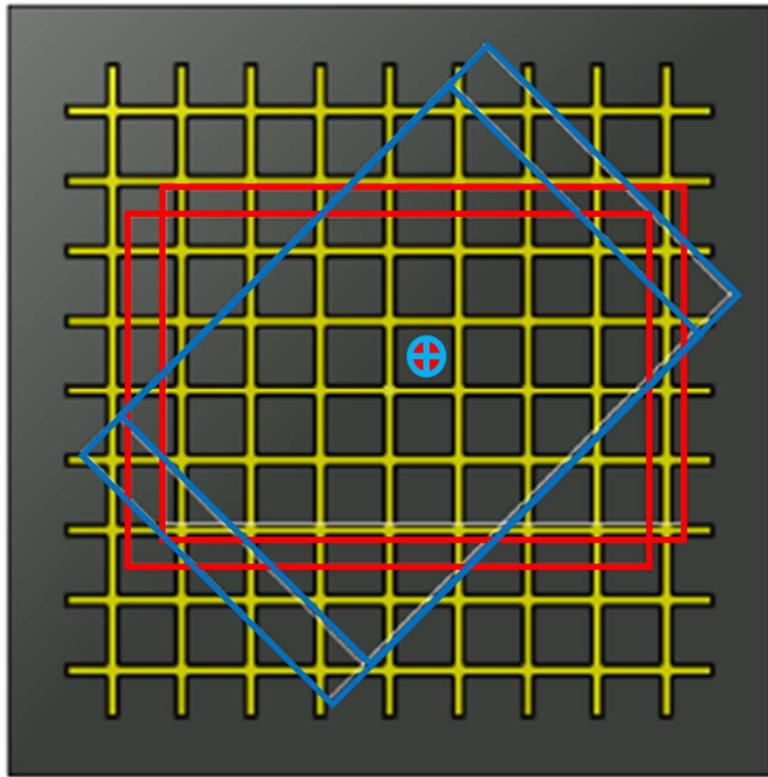
Figure 8. General shape of injected part and specimens cut by water jet.

The chosen material configuration was PEI plate, PPS overmolding. The overmolding was 10 mm high, the thickness of the wall was 2.5 mm and the inner side length of a square was 17.5 mm. To simplify the milling of the mold, a type "A" foot shape was chosen (see Figure 4). Some pictures of the plate before after water jet abrasion cutting and of the specimens after water jet abrasion cutting are also shown in Figure 13.

4th step: The last step is the stamping and overmolding. The CETIM installation consists of a 500 tonne press coupled with a 2000 bar injection press. The gripping hand carries out the last transfer from the infrared oven to the press. The distance between the two devices is reduced to a strict minimum to respond to the problem explained above. The needles of the gripping hand are suitable for gripping the preform here since it is in a very viscous state but not liquid. Once the preform has been placed on the mold, the injection cycle begins: the press (and therefore the mold) is closed and the injection unit injects the PPS. At closing, pressure is of the order of 300 bars and the injection temperature of approximately 300 °C. This injection phase lasts for approximately 7 seconds and is followed by a maintenance phase of approximately ten seconds. At the end of this process, the press rises and the overmolded plate can be extracted from the mold (see Figure 13). This plate is then cut with a water jet according to the diagram in Figure 8 to make the impact test pieces (see Figure 14).

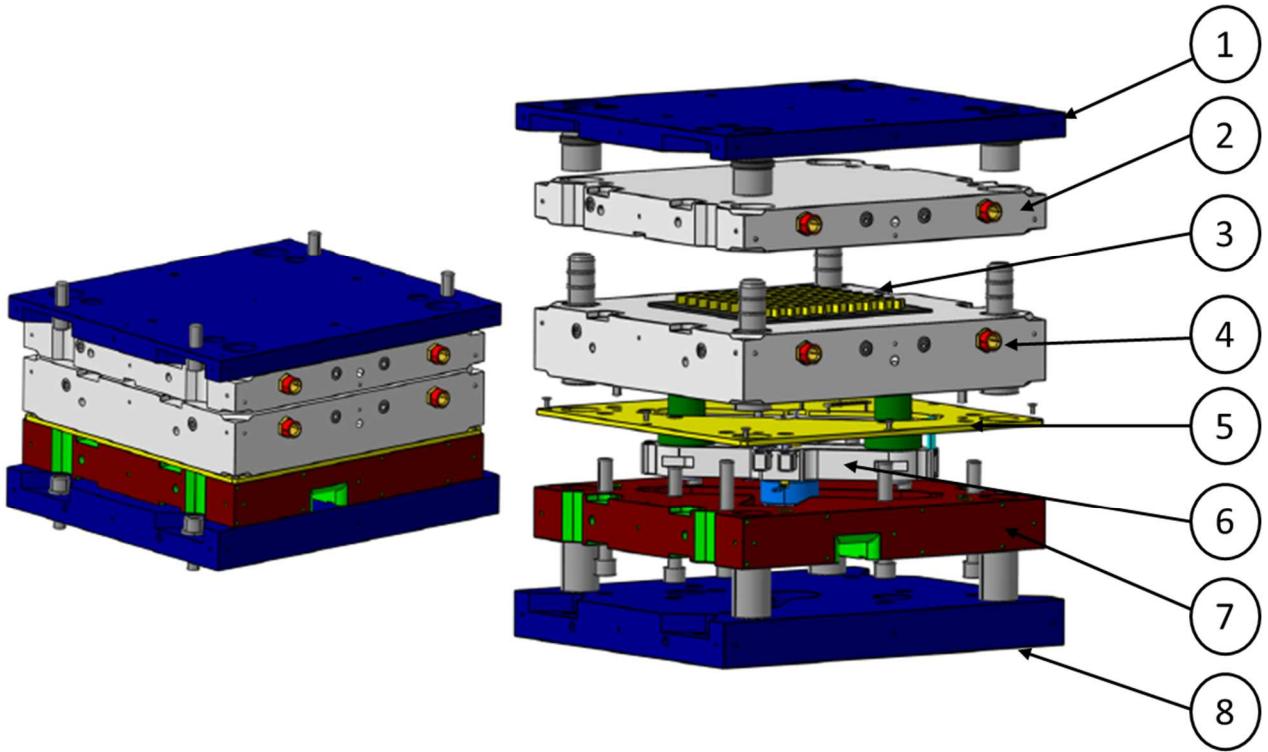
The mold was a very complex part to design and required the expertise of external companies [22], [23] to avoid its being damaged or destroyed by the first injections. It was maintained at a temperature of around 200°C during the injection phase. The CETIM press used allowed the compound to be injected up to a pressure of 1890 Bars. MODFLOW simulations had shown that, with PPS and with two injection points, a pressure of around 200 bars was sufficient to allow injection without defects, with an injection time of less than 1 s. Note that, with a PEI-based compound, the pressure would have risen to 650 bars with a doubled injection time, which could cause problems on real industrial parts. The mold consisted of 7 main parts made of steel and fibreglass (Figure 9): 1: Upper support; 2: Upper mold plate (the grid is machined in); 3: molded part; 4: lower mold plate (the plate shape is machined in); 5: isolating plate (fibreglass); 6: hot injection block; 7: Hot device plate; 8: Lower support.

Figure 9. Structure and main parts of the mold.

The upper parts 1 + 2 move and are linked to the upper part of the injection molding machine. They are centred on the lower mold by 4 bushings. Plates 2 and 4 (in grey) are machined to integrate an oil circuit that maintains the temperature of the mold so that the cavity of the grid is hot enough to avoid the injected material undergoing thermal shock during its injection. CETIM has the necessary facilities to implement this type of heating, which is more practical than the use of heating rods. Among the peculiarities of plate 4, two notches were also machined so that a blade could be slid under the composite plate to facilitate demolding should the injected plate get stuck in the cavity when the mold was opened after injection. In fact, this proved to be very handy as the plate remained stuck in about 75% of the cycles.

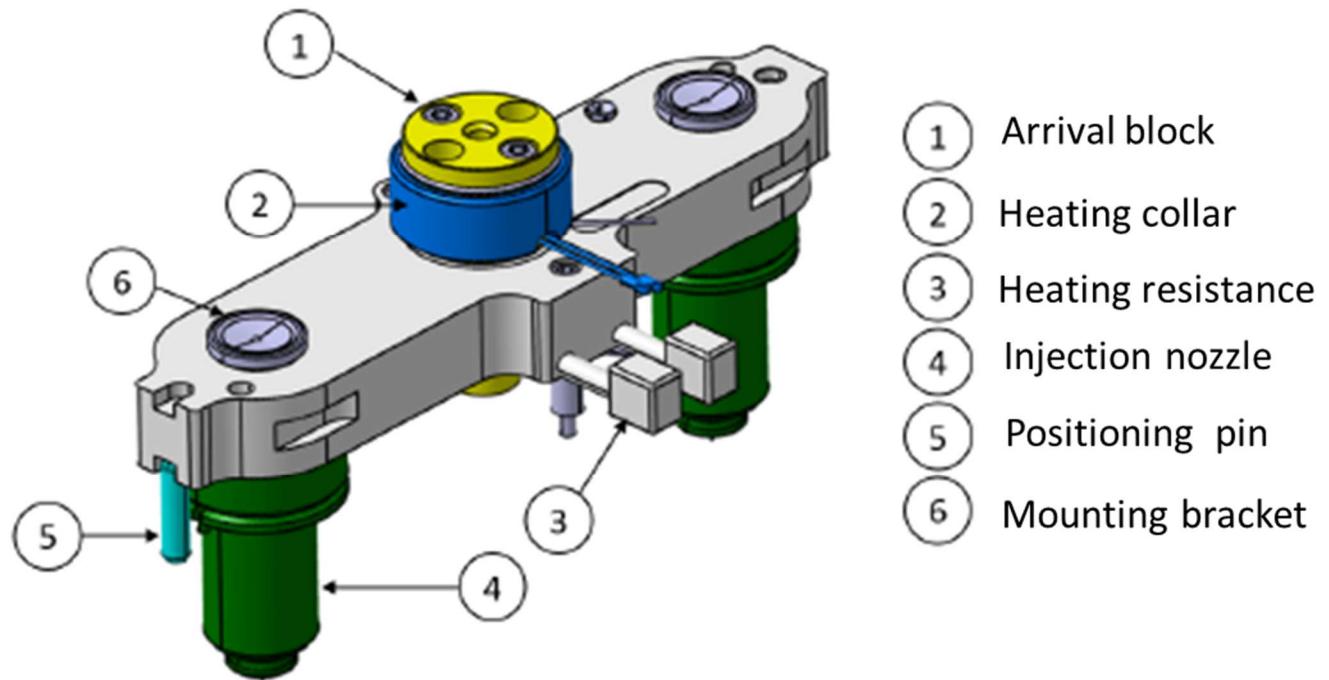
Figure 10. Hot block structure.

The use of two injection points has a direct consequence on the design of the mold since it is necessary to provide additional equipment for integration into the heart of the mold to make it possible to separate the incoming injection channel into two channels feeding the two injection nozzles. This equipment is known as a “hot block”, and specialized companies design and manufacture such products [22], [23]. The hot block is itself a complex piece of equipment and, for large series, it is preferable to have a hot

block optimized and designed specifically for the desired application. This obviously depends on the material injected, the number of injection points and the desired surface finish, which has an impact on the types of nozzles used. The hot block requires special installation in plate 6 and a specialist must travel to carry out its installation and adjustments.

Insulating plates are essential for safety reasons. Mainly composed of glass fibers and epoxy, they help to contain the heat within the mold and thus provide protection for the press operators. The mold is therefore entirely streamlined by these insulating plates. An insulating plate (5, figure 9) has also been added between the lower mold plate (4) and the hot block and its support plate (6). This isolates the hot block from the heating oil circuit and also limits the spread of heat to the bottom plate of the press. Note that this plate is much more resistant in compression than standard outer plates since it must withstand the forces introduced by the press during injection. Figure 10 shows the complete mold equipped with

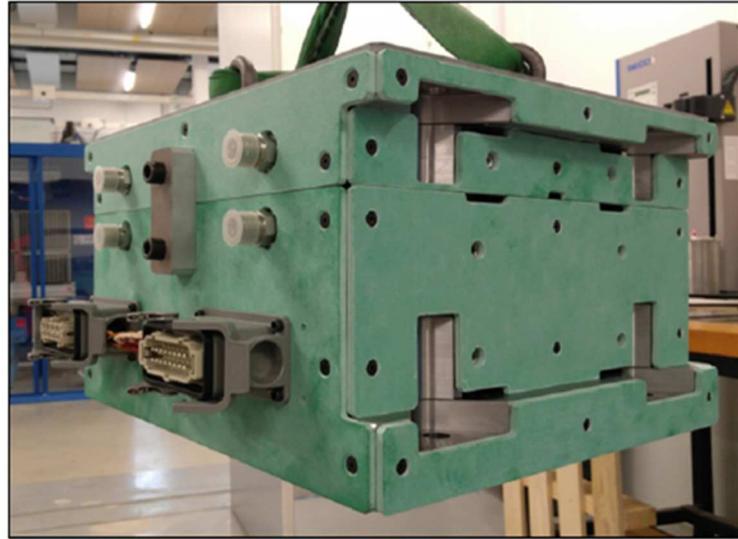
Figure 11. Exterior view of the injection mold equipped with its insulating plates.

the insulating plates. All in all, the development of the mold required around 6 months of work at a cost of around 20 k€ for machining, various parts, and the cost of technical assistance.

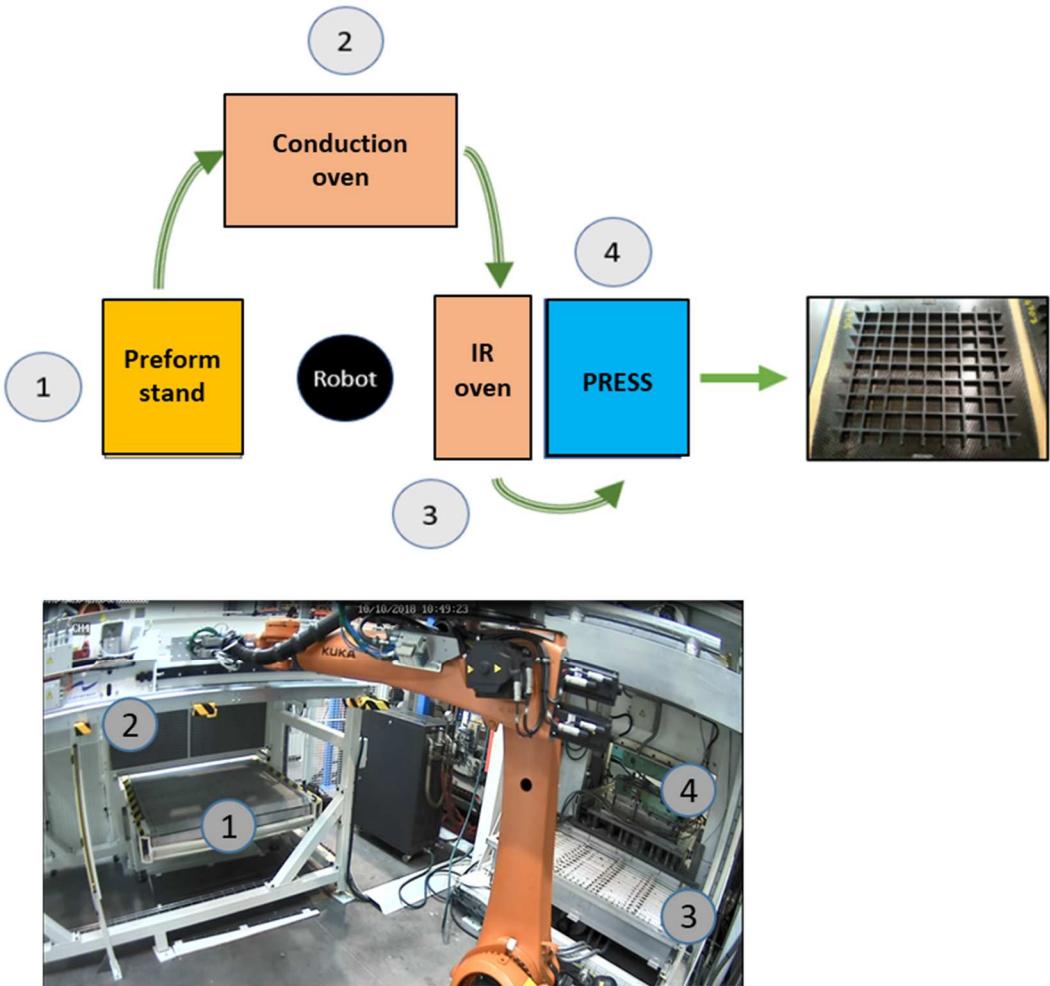
The entire manufacturing process is divided into several stages, which are essentially composed of periods of transfer, heating and injection. The thermocompression line installed at CETIM thus comprises a conduction furnace, an infrared furnace, a vertical press equipped with its injection unit and a robot for transferring preforms between these different items. The process is illustrated in Figure 12. The steps take place successively as follows:

Figure 12. Operating diagram of the thermocompression line and overview of equipment.

1st step: The pre-cut composite preform is placed on the starting stand. In our case, the dimensions of the preform were 220 mm x 220 mm and were chosen because, on the one hand, they allowed post-manufacturing cuts to be made and, on the other hand, they offered a sufficient surface area to have a satisfactory joint plane when the preform was placed on the press during the overmolding phase. These dimensions also correspond perfectly to the overall dimensions of the Tencate plate, thus minimizing the quantities of scrap after cutting of the preforms.

2nd step: The preform is brought into the conduction oven using a gripping hand (denoted robot in Figure 12) made up of suction cups and needles specially adjusted for the preform. At this stage of the process, the preform being in solid form, it is the suction cups that allow its transport to the conduction furnace. Once the

preform has been placed in the oven, a first heating cycle is initiated, the objective being to uniformly heat the preform both on the surface and in the thickness. In our case, this cycle lasted 40 seconds and reached a temperature of 220°C. The melting temperature of PEI is 310°C according to data from the manufacturer, Tencate.

3rd step: A second transfer step is then required to bring the preform from the conduction oven to the infrared oven. The infrared oven has a heating set point of 390 °C, a temperature higher than the melting temperature of the PEI. This higher set point is justified by the fact that the preform is not made of PEI only; all the carbon fibers also need to be heated. In addition, it is important that the preform should come to a state as close as possible to melting when it is placed in position on the press for the injection step. The mechanical bond will be all the more robust if the two resins concerned (that of the preform and that injected for the overmolding) are both molten as the miscibility between them will obviously be improved. It is therefore necessary to anticipate that the preform will move away from the melting point as soon as the infrared oven is opened for the last transfer step. The time planned for this heating period is 80 seconds.

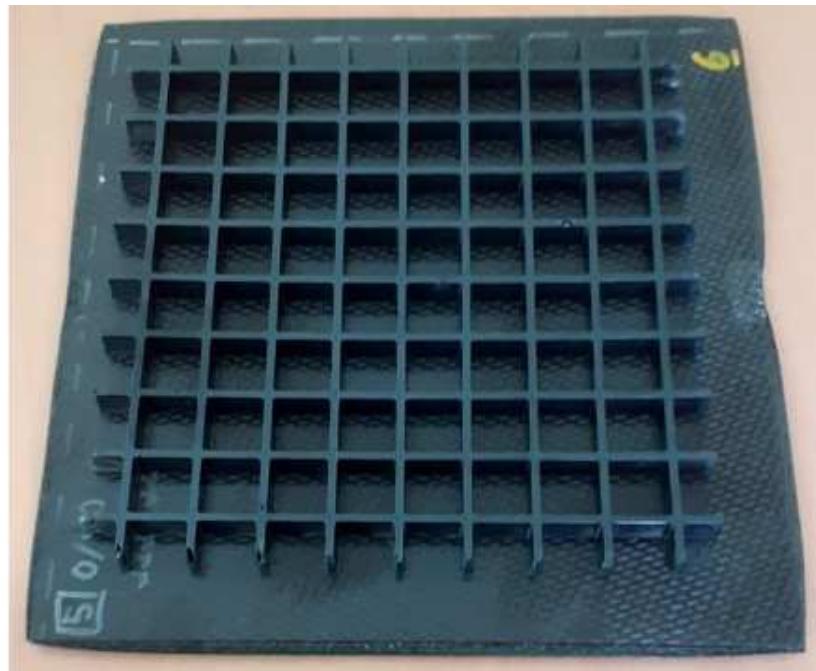
Figure 13. Manufactured plate after injection.

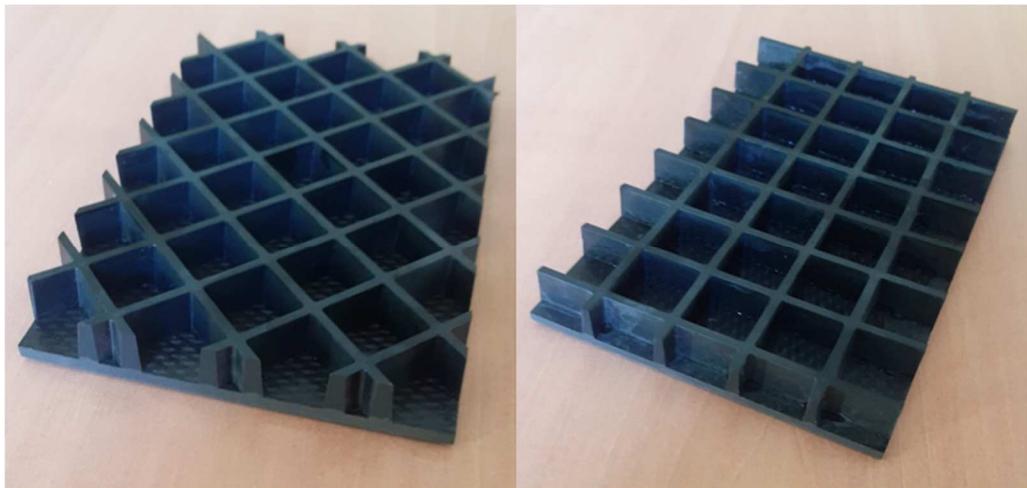
Figure 14. Specimens for impact testing.

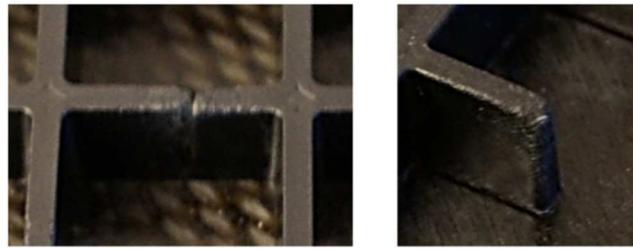
For all plates manufactured under normal injection conditions, no bonding defect between the overmolding and the plate was observed. Regarding the injection itself, occasional burning phenomena were found (see Figure 15) on the ends of the injection grid and sometimes in the middle of certain ribs. These were due to the formation of small gas pockets in the mold cavity during injection, into which the resin was unable to penetrate. While these defects were not considered worrying when they were located at the ends of the ribs, the situation was different for those present in the middle of a rib, since a structural weakness was clearly present. However, there were

generally only two burns, at most, per plate produced and their position varied. When the plates were cut to match the dimensions of the impact specimens, the ribs sometimes separated slightly from the composite plate (only for certain injection conditions). This gave us a first clue about the fragility of the overmolding when a non-ideal set of parameters is used. In addition, during these cuts, it was also noticed that some ribs were not completely filled, betraying the presence of gas pockets that Moldflow did not detect during the simulations.

Figure 15. Example of a burn-type defect observed towards the center of the grid and at one end.

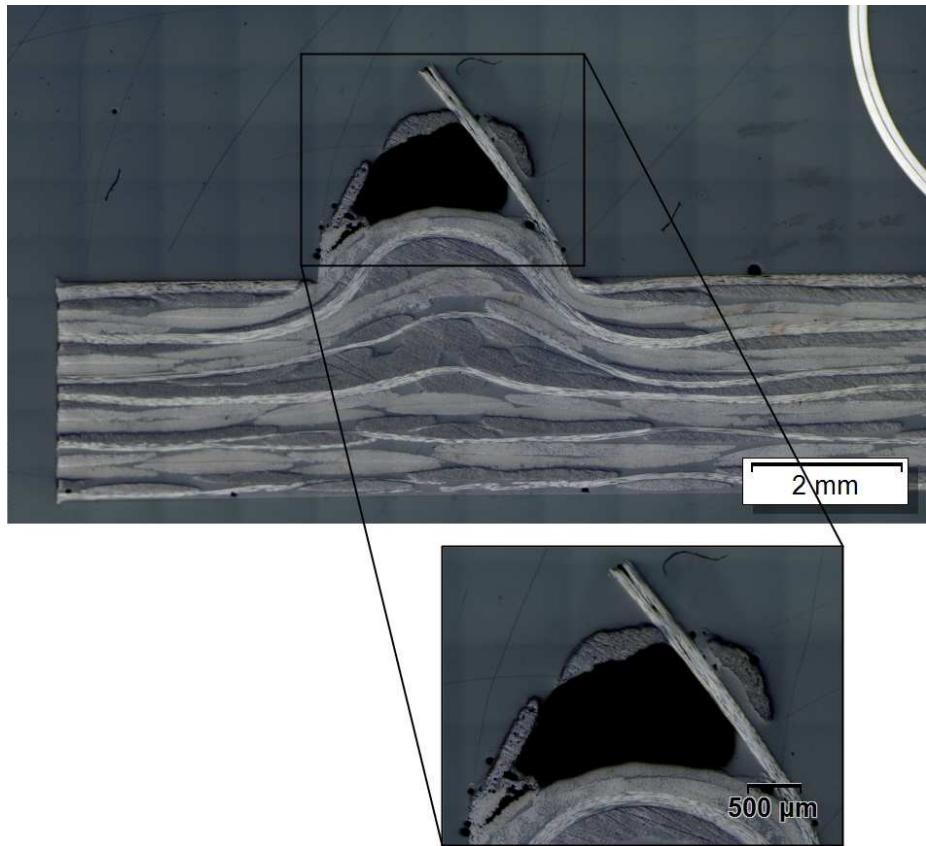
The poor impact results presented in the next paragraph led us to look more closely at the interface between the molded part and the plate by carrying out a tomography analysis on remaining pristine plates. In fact, there were many, sometimes very significant, defects. A local undulation of the upper layers of the plate was systematically observed in line with the ribs. In the extreme case presented in Figure 16, enormous porosity and fiber breaks were found. In other cases, the injected resin was also seen to raise the adjacent layers. Clearly, these defects, which had not been observed on the tab test pieces, weakened the impacted specimens.

Figure 16. Cross-section of carbon-PEI laminated plate after a stage at PEI melting temperature in the injection mold.

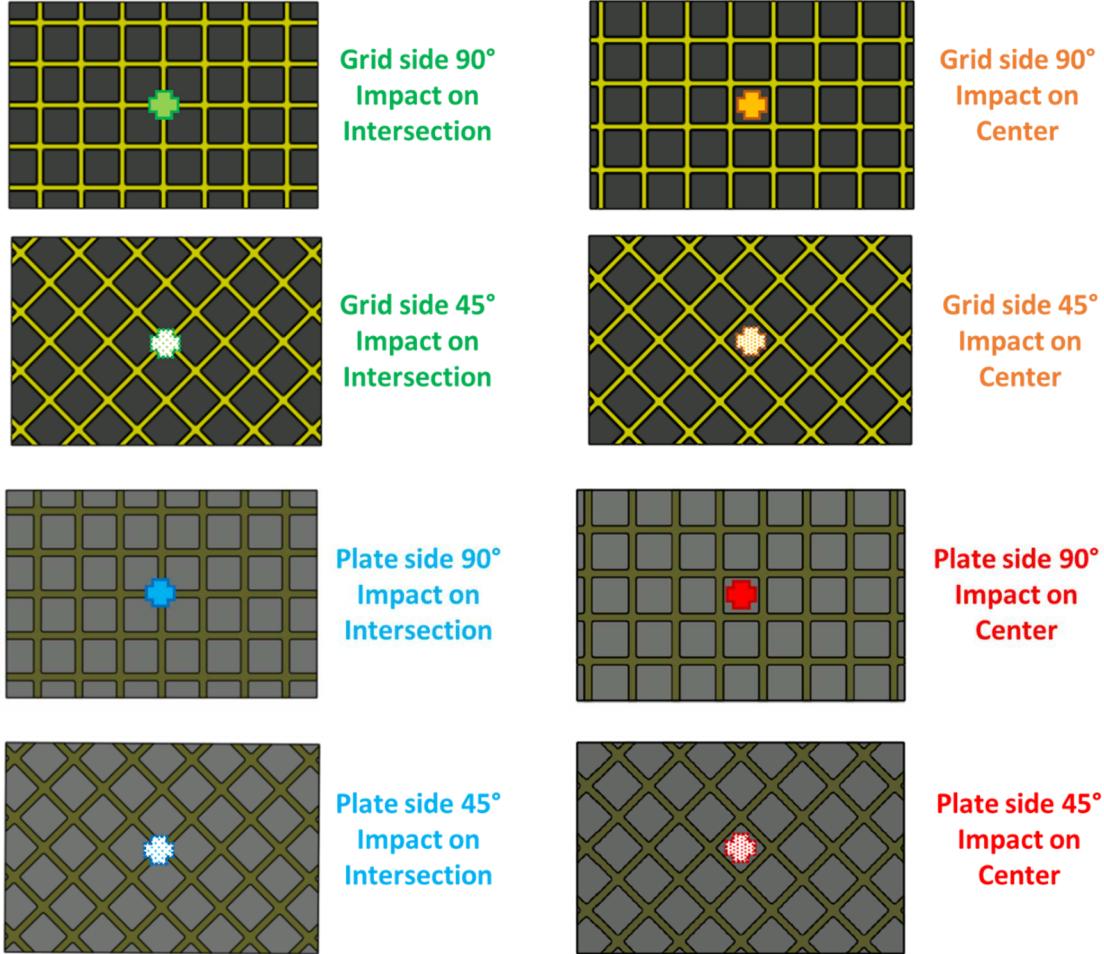
It was also important to study the impacts on the non-overmolded side of the composite plate because, depending on the design, the ribs may or may not be visible. For this reason, the impact tests were carried out on both sides of the overmolded plate at the two locations mentioned above. For clarity, Figure 17 summarizes the four front and back impact locations, for 90° and 45° grids. The color conventions and continuous lines (90° grid)

or dotted lines (45° grid) are kept for the test curves. Reference tests were also carried out on non-overmolded plates to determine the BVID (Barely Visible Impact Damage). Consequently, to remain in the damage tolerance domain, the impacts were at 5, 10 and 15 J, with one plate per configuration, i.e. a total of $8 \times 3 = 24$ tests.

Figure 17. The 8 impact configurations.

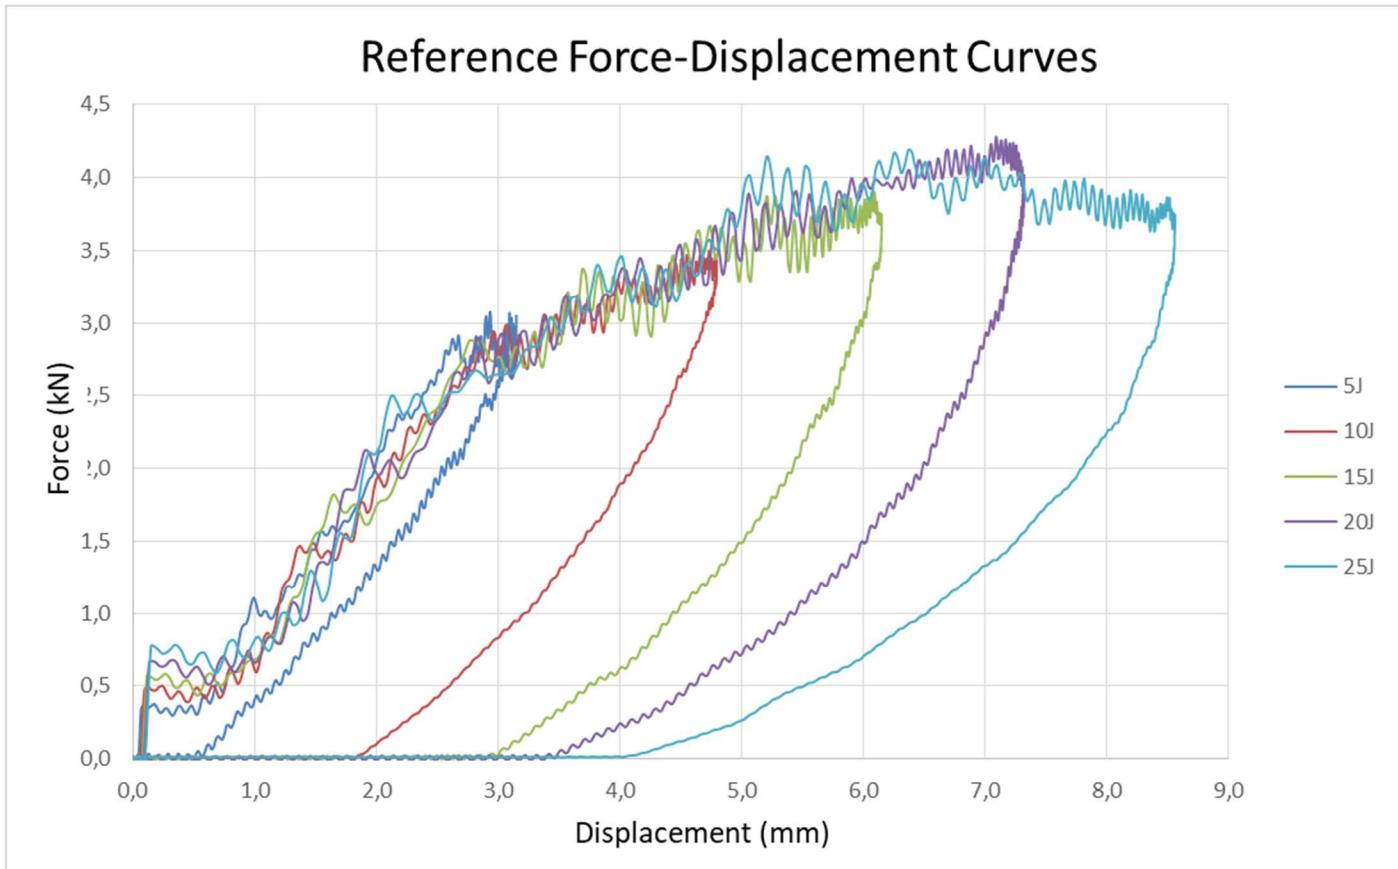
Five tests were carried out, at 5, 10, 15, 20 and 25 Joules, on Tencate specimens $100 \times 150 \text{ mm}^2$ without overmolding following the method described in [11] or [30]. The displacement force curves are given in Figure 18. A first contact zone of 0.5 mm is noticeable, followed by an almost linear rise, which is noisy because of the dynamics of the impact, then a change in slope linked to the creation of damage in the plate. These curves are very similar to those of Vieille et al. [12] although the thermoplastics are different (PEEK and PPS). The contact zone may be connected with a phenomenon of clearance linked to the plate/assembly contact due to plate springback. The change in slope is attributed to the beginnings of fiber breakages at 90° and 0° [12], which then multiply. The measurement of the residual indentation, due to the relaxation effects, was carried out more than 72

Figure 18. Force-displacement curves for impact tests on Tencate PEI plates without overmolding.

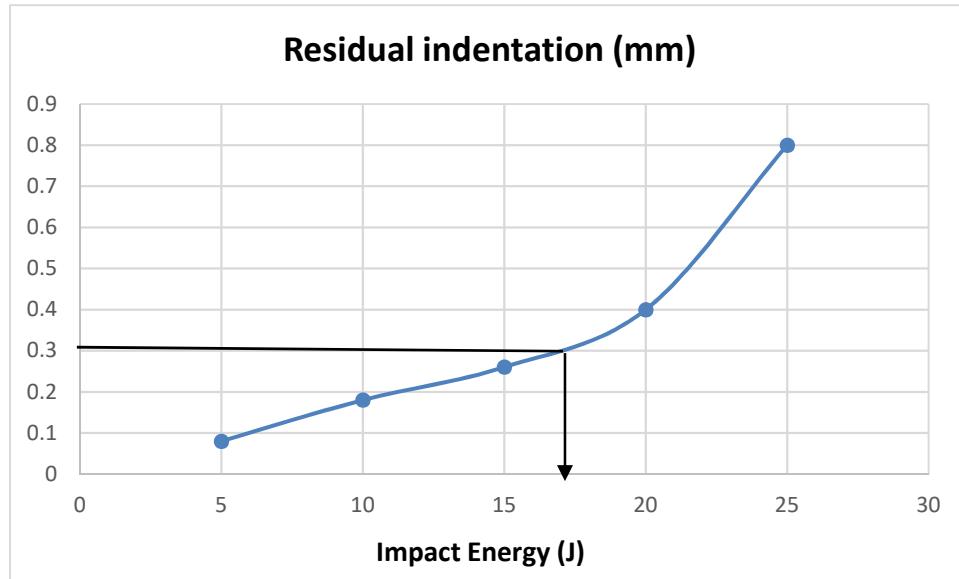
hours after the impact test. The measuring device was an Alicona Infinite Focus SL which is an optical 3D measuring system. A measurement time of 20 minutes per specimen was chosen as the best compromise between time spent and precision. The results are presented in Figure 19. The BVID being set at 0.3 mm in the case of a detailed inspection [25], the threshold energy is was 17 J. To assess the damage tolerance of these structures, tests could be performed at 5, 10 and 15 J. The curves obtained will also serve as a reference with respect to the impacts on the overmolded structure.

Figure 19. Looking for BVID.

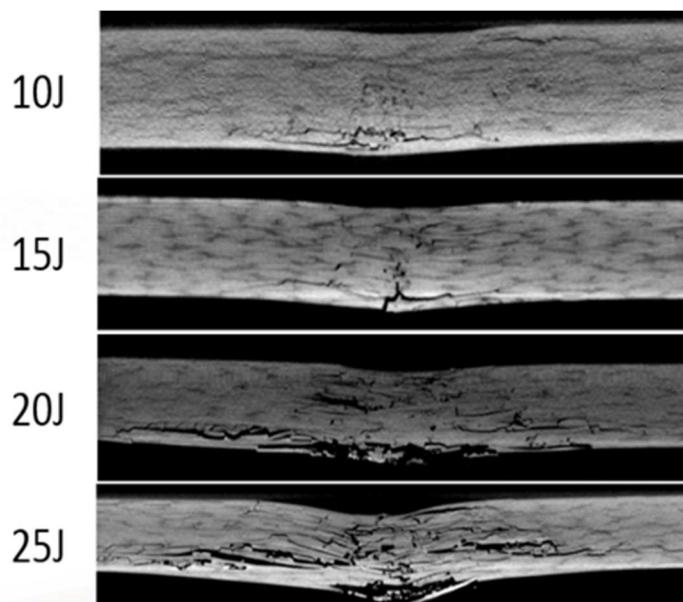
Figure 20 shows the tomographic images in sectional view and centred on the impacts of the reference thermoplastic plate impacted at 10 J, 15 J, 20 J and 25 J. It is interesting to note that, from 10 J, the plate has matrix cracks and a beginning of delamination on the opposite side to the impact. The damage gradually intensifies as the impact energy increases. From 15 J, fiber breaks are visible on the face opposite the impact. From 20 J, the impact zone can be judged to be considerably damaged. At 25 J, the damage has spread throughout the thickness of the plate and is close to perforation. These modes of damage are, of course, always present with overmolded plates.

Figure 20. Tomography of damage on non-overmolded plate.

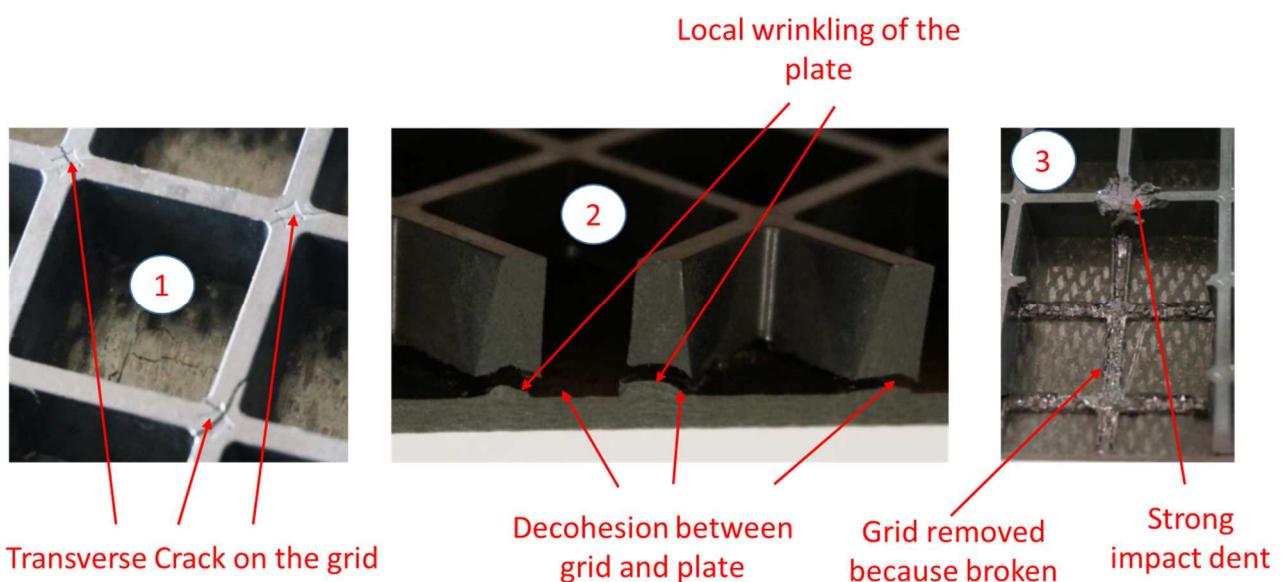
The main types of damage qualitatively observable with the naked eye on the overmolded grid are shown in Figure 21. In the first photo, cracks are visible in the ribs of the grid. In the second photo, it is clear that the grid has separated from the plate. The photo shows one side of the plate but these cracks are of the same nature in the center of the plate. Note that the failure does not occur quite at the foot of the rib (at the geometric level of the rib/plate interface but slightly higher). Corrugations in the plate are clearly visible at this point and it appears that part of the plate has been pushed into the cavity of the grid as already shown in Figure 16. Therefore, the breakage still occurs at the interface of the two thermoplastics. In the third photo, the impact was very strong and an area of the grid broke and became detached.

Figure 21. Type of damage on the overmolded grid.

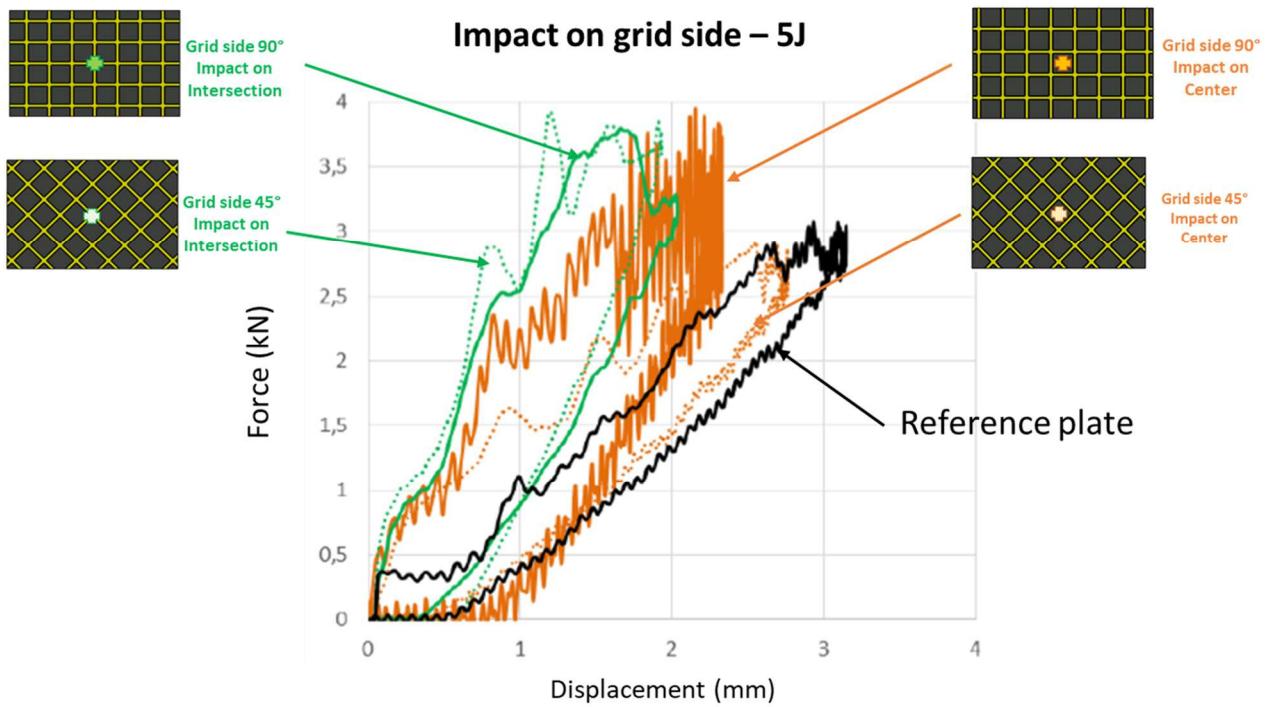
The displacement force curves for an impact at 5 J are given in Figure 22 for the molded grid side, and in Figure 23 for the plate side. Globally, for the plate side impacts, the response appears identical, the contact phase is similar and is probably due to the curvature of the plate generated by the springback. The energy absorbed for the reference plate is 1.64 J and for the overmolded plates it is higher, oscillating between 1.74 J. and 2.97 J. The

maximum delamination is reached for the minimum absorbed energy, which suggests that the debonding occurred early and consumed little energy. It could therefore be a manufacturing defect. However, in this case of early debonding, there is thus a contribution of the grid to the energy absorption and the grid is also damaged. In the case of the impact on the overmolded grid side, there is a significant difference in behaviour according to whether the impact is on the grid or at the bottom of a square. The energy absorbed is greater and varies from 2.31 J to 3.01 J, the minimum being obtained for the same configuration as before, with a debonding of 60% of the grid. There is no longer a contact zone and the initial slopes are greater, which is logical given the contribution of the grid to the bending. The maximum contact forces are also increased relatively to the reference plate when the impact falls directly on the grid. In this case, the damage is minimal and the grid does play a protective role. On the other hand, during an impact at the bottom of a square, especially for the 90° case, the signal is very noisy, which probably corresponds to the grid/plate debonding up to 60% as noted. However, this phenomenon is not present for the plate with a 45° grid, which shows more similarity with the impact on the reference plate.

Figure 22. Displacement force curves for an impact at 5 J, overmolded grid side.

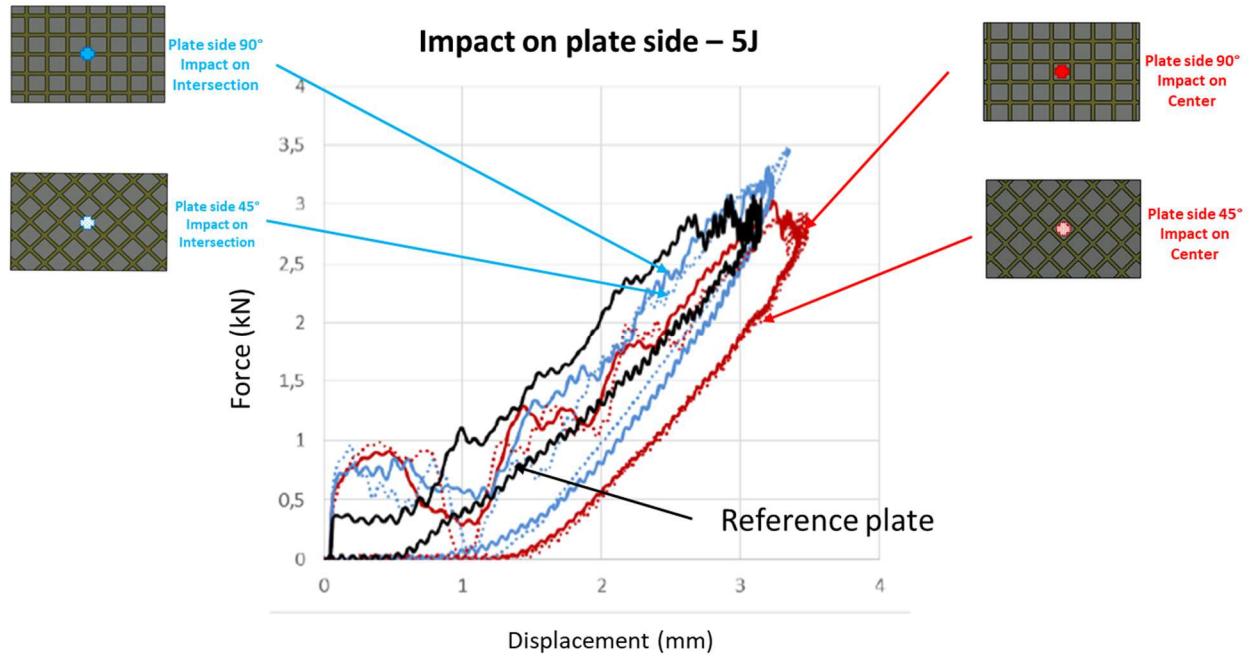
Figure 23. Displacement force curves for an impact at 5 J, plate side.

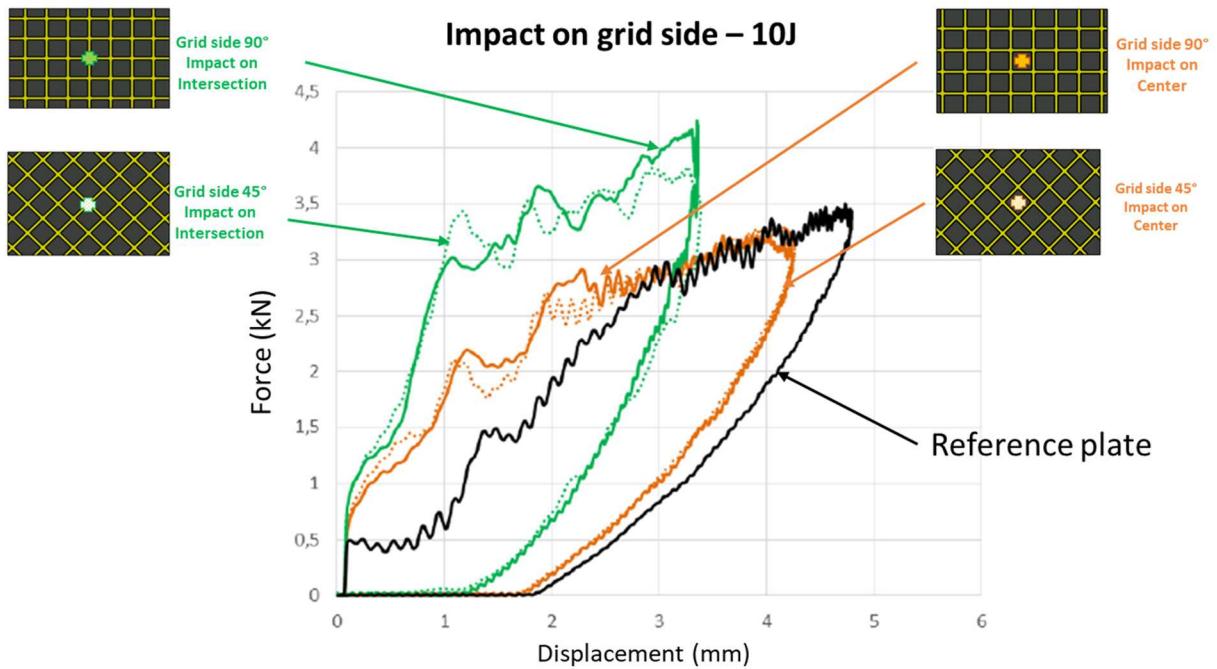
Figure 24 gives the force/displacement curves for an impact at 10 J on the overmolded grid side and Figure 25 gives them for the plate side. Globally, the same trends as with 5 J are observed. For the plate side impacts, the energy absorbed from the reference plate is 6.07 J and, here, the energies range from 6.77 J to 7.25 J with an aberrant point at 3.21 J. For this test, it appears probable that the impactor was badly centered on the mesh. For impacts on the grid side, the absorbed energies are 7.04 J for the impact on an intersection and 6.79 J and 6.96 J for an impact at the bottom of the mesh, which become comparable to the impacts on the plate side in terms of response. The damage, although greater, is also limited when an intersection is impacted.

Figure 24. Displacement force curves for an impact at 10 J, overmolded grid side.
