Manufacturing and impact behaviour of aeronautic overmolded grid-stiffened thermoplastic carbon plates

F. Neveu, C. Cornu, P. Olivier, Bruno Castanié. Manufacturing and impact behaviour of aeronautic overmolded grid-stiffened thermoplastic carbon plates. *Composite Structures*, 2022, 284, pp.115228. 10.1016/j.compstruct.2022.115228 . hal-04108752

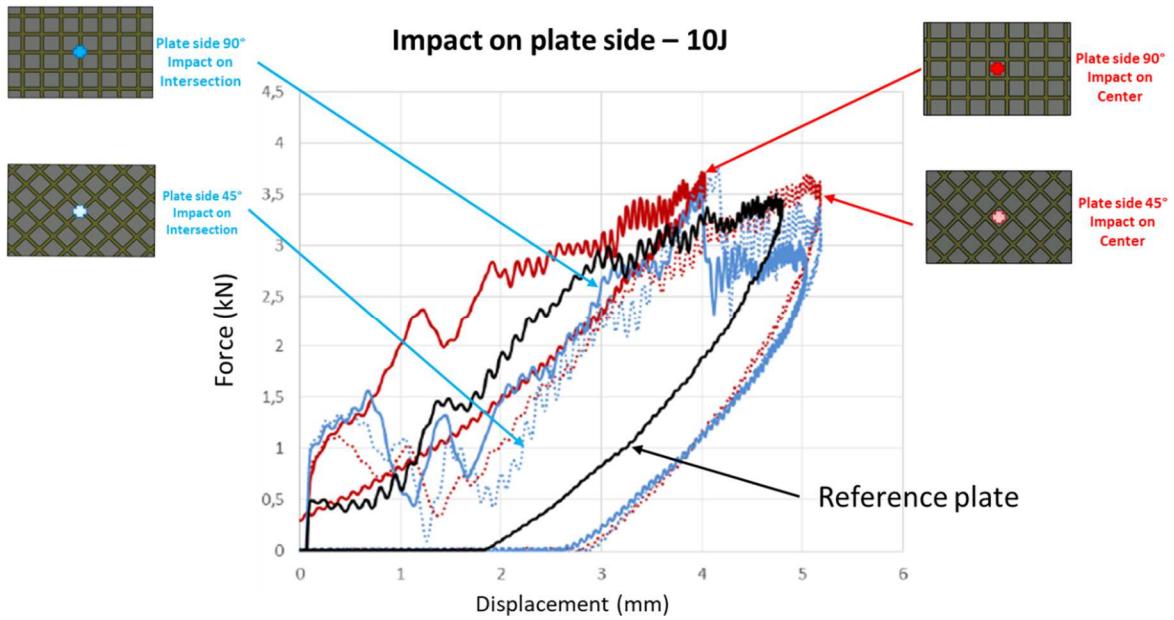
Figure 24 gives the force/displacement curves for an impact at 10 J on the overmolded grid side and Figure 25 gives them for the plate side. Globally, the same trends as with 5 J are observed. For the plate side impacts, the energy absorbed from the reference plate is 6.07 J and, here, the energies range from 6.77 J to 7.25 J with an aberrant point at 3.21 J. For this test, it appears probable that the impactor was badly centered on the mesh. For impacts on the grid side, the absorbed energies are 7.04 J for the impact on an intersection and 6.79 J and 6.96 J for an impact at the bottom of the mesh, which become comparable to the impacts on the plate side in terms of response. The damage, although greater, is also limited when an intersection is impacted.

Figure 25. Displacement force curves for an impact at 10 J, plate side.

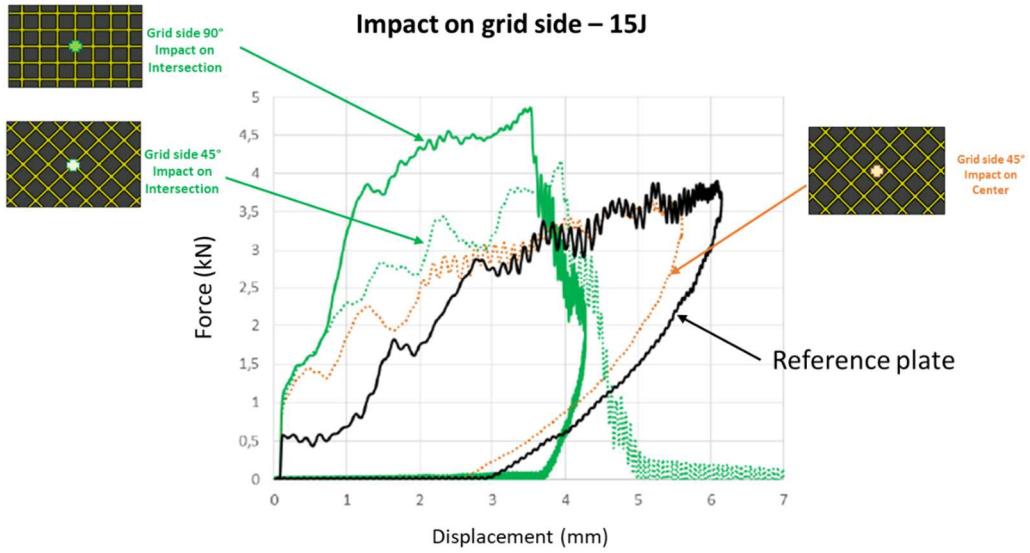
The displacement force curves for an impact at 15 J are given in Figure 26 for the overmolded grid side, and in Figure 27 for the plate side. Two tests are missing due to an experimental problem but do not change the observed trends. Globally, the behaviour is identical with, of course, the greatest damage when the grid side is impacted. The grid is destroyed in both cases of location of impact and the debonding is complete, or at 80%

Figure 26. Displacement force curves for an impact at 15 J, overmolded grid side.

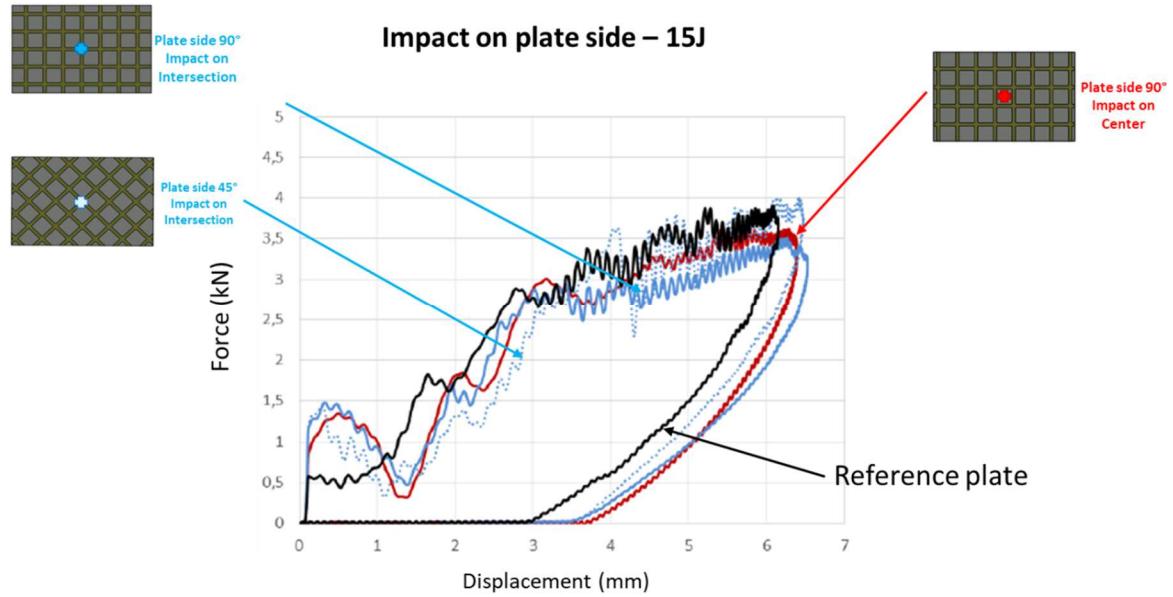
when the bottom of the mesh is hit. On the other hand, it is noticeable that, during the impacts on the plate side, the behaviour is very homogeneous and very similar to that of the plate alone.

Figure 27. Displacement force curves for an impact at 15 J, plate side.

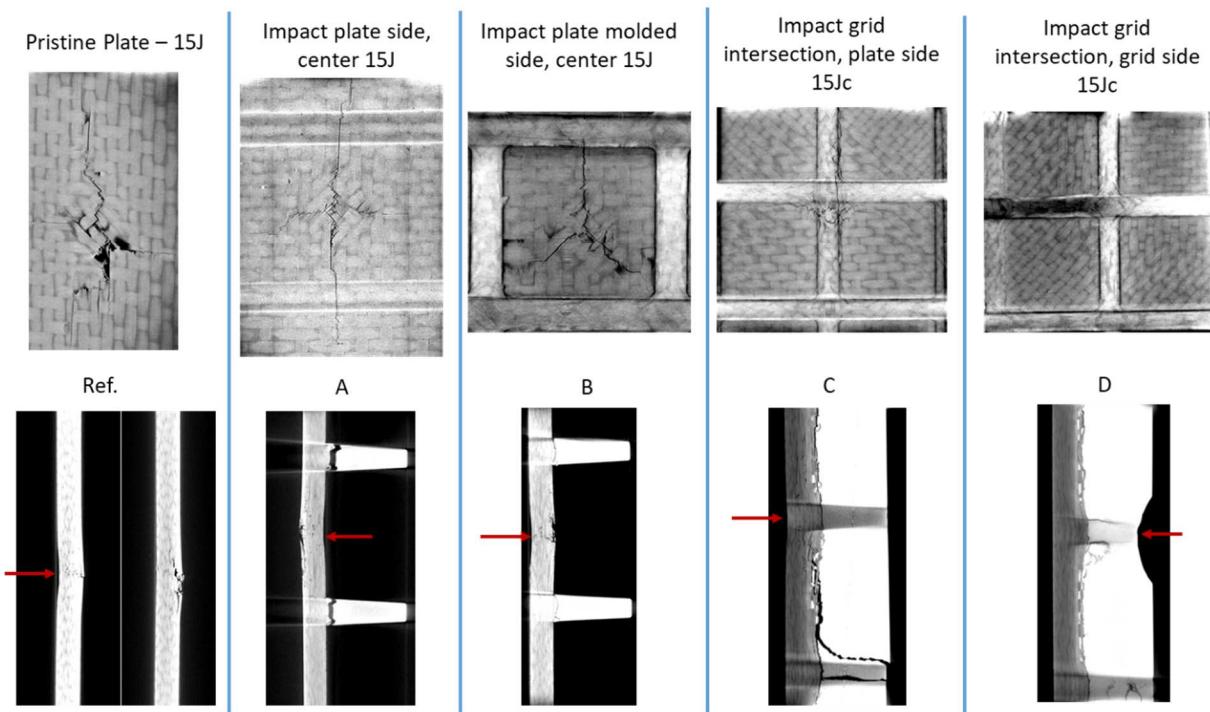
It is very difficult to analyse the effects of impact with qualitative visual observations and force-displacement curves only. So a tomographic analysis was performed. From the tomographic images, it is clear that the grid conditions the damage to the plaque according to the location of the impact. Figure 28 compares the damage at

different impact locations for an energy of 15 J. A non-overmolded plate is also added to the comparison for reference. It can be observed that the extent of the damage undergone by the composite plate is lower for cases B, C and D. For case B, the structure of the overmolded grid seems to have a “shield effect” on the propagation of cracks, which is not observed in case A since the grid is located on the same side as the impact. When the impact is located on the plate side and directly opposite a rib crossing (case C), the damage in the plate is very small compared to what is seen in the reference plate. This can be explained by the flexural stiffness provided by the grid in the impact zone. Finally, in case D, the overmolded grid partially exploded on impact but absolutely no damage was observed, visually or by tomography, on the plate. This result could also be observed for an impact energy of 25 J. When the overmolding grid is directly impacted, it completely dissipates the impact energy and thus protects the composite plate from possible damage.

Figure 28. Tomographic images for different impact locations at 15 J.
