# Crashworthiness of poplar wood veneer tubes

**Keywords:** Wood, Poplar, Crushing, Energy absorption, Static, Dynamic

## Abstract

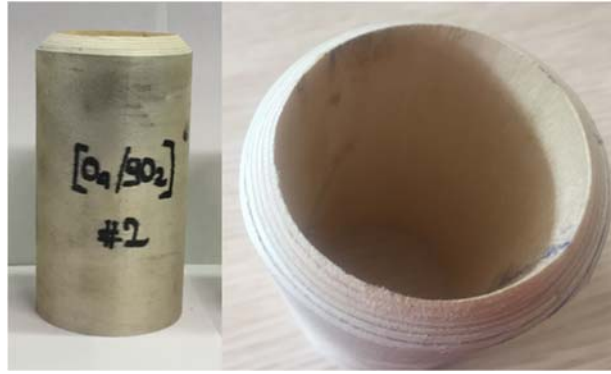
Fig. 2: Pristine sample  $[0_4/90_2]$  - #2

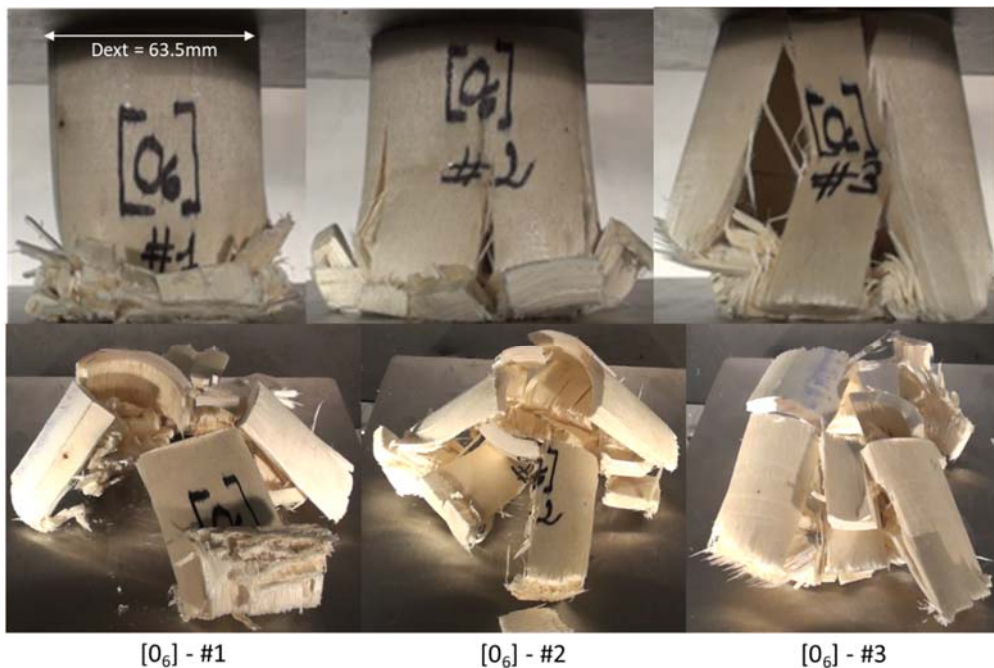
**Fig. 6: Failure patterns of  $[0_6]$  tubes under a crush displacement of 40 mm and post-mortem patterns.**

The first damage corresponded to the appearance of longitudinal cracking along the fibres after the peak load (Fig. 5 (a)). These cracks cut the tube into several sections (Fig. 6). Then each section began to bend until it broke. The longitudinal crack spread over a large part of the tube, leading to a total loss of stiffness of the tube and marking a crushing force close to 0. For these types of tubes, the absence of a plateau is to be noted and, therefore, energy absorption performance is difficult to exploit and the expression does not necessarily have a clear meaning (Fig. 5 (a)). Delamination between layers also occurred, and fragmentation could also be observed following these failures in fibres at  $0^\circ$  stressed under bending (Fig. 6). It generated the formation of bundles, five large ones (almost half the length of the tube) being counted for tubes # 1 and # 3, and 6 for tube # 2. This failure mode was observed on the three tubes and was repeated although certain cracks did not start to form at the same time, which explains the shift in the force-displacement curves (Fig. 5 (a)). However, this is a very unstable mode of failure and results in oscillations generating a small amount of absorbed energy due to the force falling to 0 N. For this configuration, the energy absorption is not optimal.

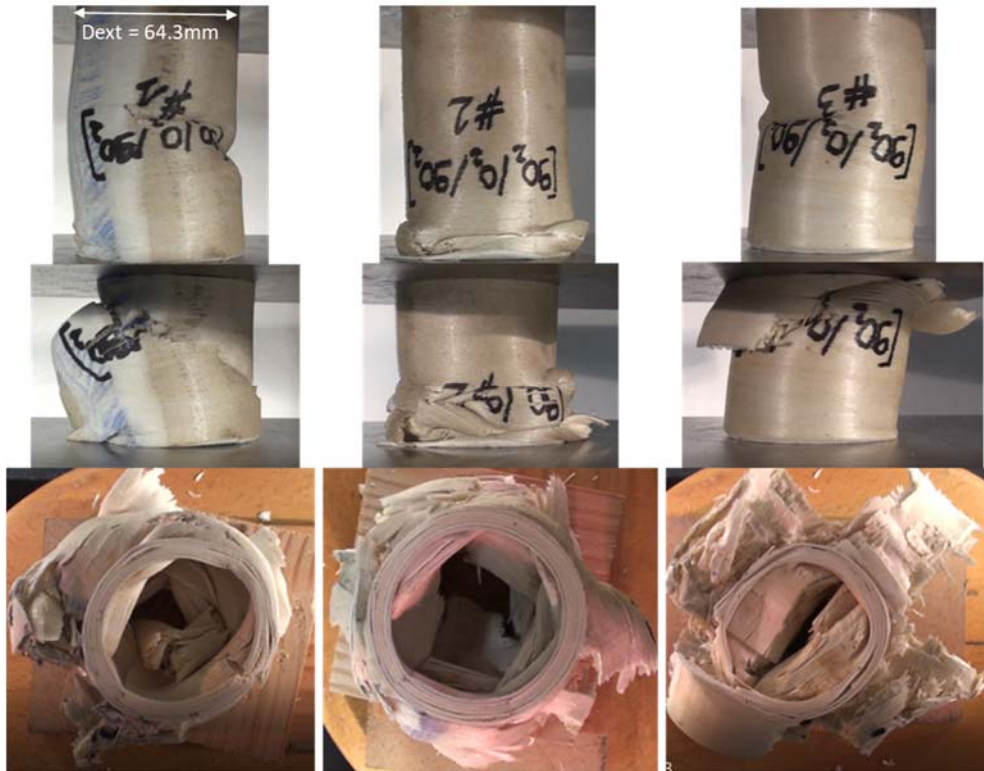
Fig. 8: First line: failure initiation of tubes  $[90_2/0_2/90_2]$  after 23.8 mm of crushing; second line: failure patterns after 60 mm of crushing and, last line: post-mortem views.

This configuration showed the influence of the number of layers at 90° on energy absorption. The initiation of damage on tubes # 1 and # 3 was unstable. In fact, it was probably due to an interaction between local buckling at the centre of tubes and overall buckling (Fig. 8). The ruin of tube # 1 spread with interpenetration while the ruin of tube # 3 spread on the opposite side of the chamfer. The damage initiation in tube # 2 occurred as expected on the chamfered side. Thereafter the failure mode of these tubes was similar to that of tubes [90/0<sub>4</sub>/90] with formation of folds (Fig. 8). Nevertheless, the folding propagation was stable with regard to the force-displacement curve of each of the tubes (Fig. 5 (d)). However, there were about half as many folds on the configuration [90/0<sub>4</sub>/90] (discussed in section 3.1.5), which explains the smaller number of oscillations on the force displacement curve. As with composite laminates, the number of 0° plies was important. Therefore, the energy absorbed and the SEA of these tubes (1 619 J and 31.6 J/g) decreased with respect to the configuration [90/0<sub>4</sub>/90] (726 J and 18 J /g). The CFE also decreased slightly from 0.71 to 0.62.

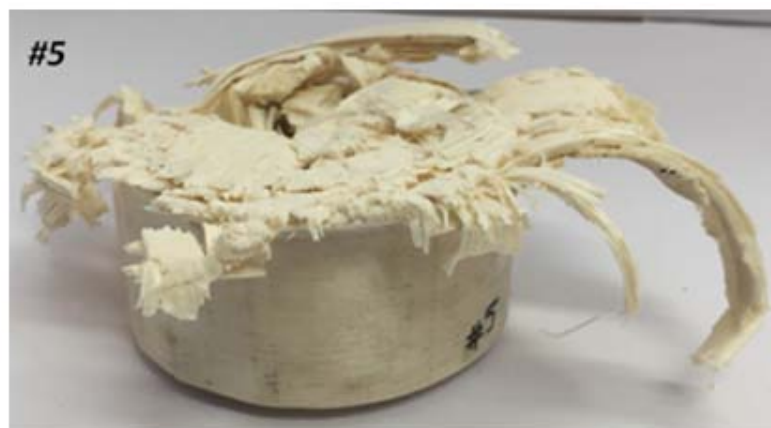
Fig. 15: Petal failure mode for poplar wood.

The failures then propagate due to local bending until local fragmentation forms macroscopic debris (Fig. 13). Small debris (almost dust) was also observed. The separation of the tube into a bundle and the bending of the latter is analogous to splaying. The observation of macroscopic debris allowed us to note that splaying did not occur in an identical way for all the tubes. By cutting the tubes it was possible to provide a more precise explanation of the ruin of the tubes used in dynamic tests (Fig. 14). The presence of debris during the crushing is responsible for the splaying as the debris forces the upper intact part to separate and splay. When crushing different configurations of carbon-epoxy fibre plates, Guillon [23] also found an accumulation of debris causing a damaged flare. Depending on the position, the debris will condition the number of folds that splay inward or outward (Fig. 15).

The formation of bundles and their bending allow the creation of petals. The formation of petals has been observed on crushed CFRP tubes for a long time [27] (Fig. 15). Splaying is also initiated by an interlaminar crack that dissociates the tubes into bundles. Again, these bundles bend and then form the petals. The

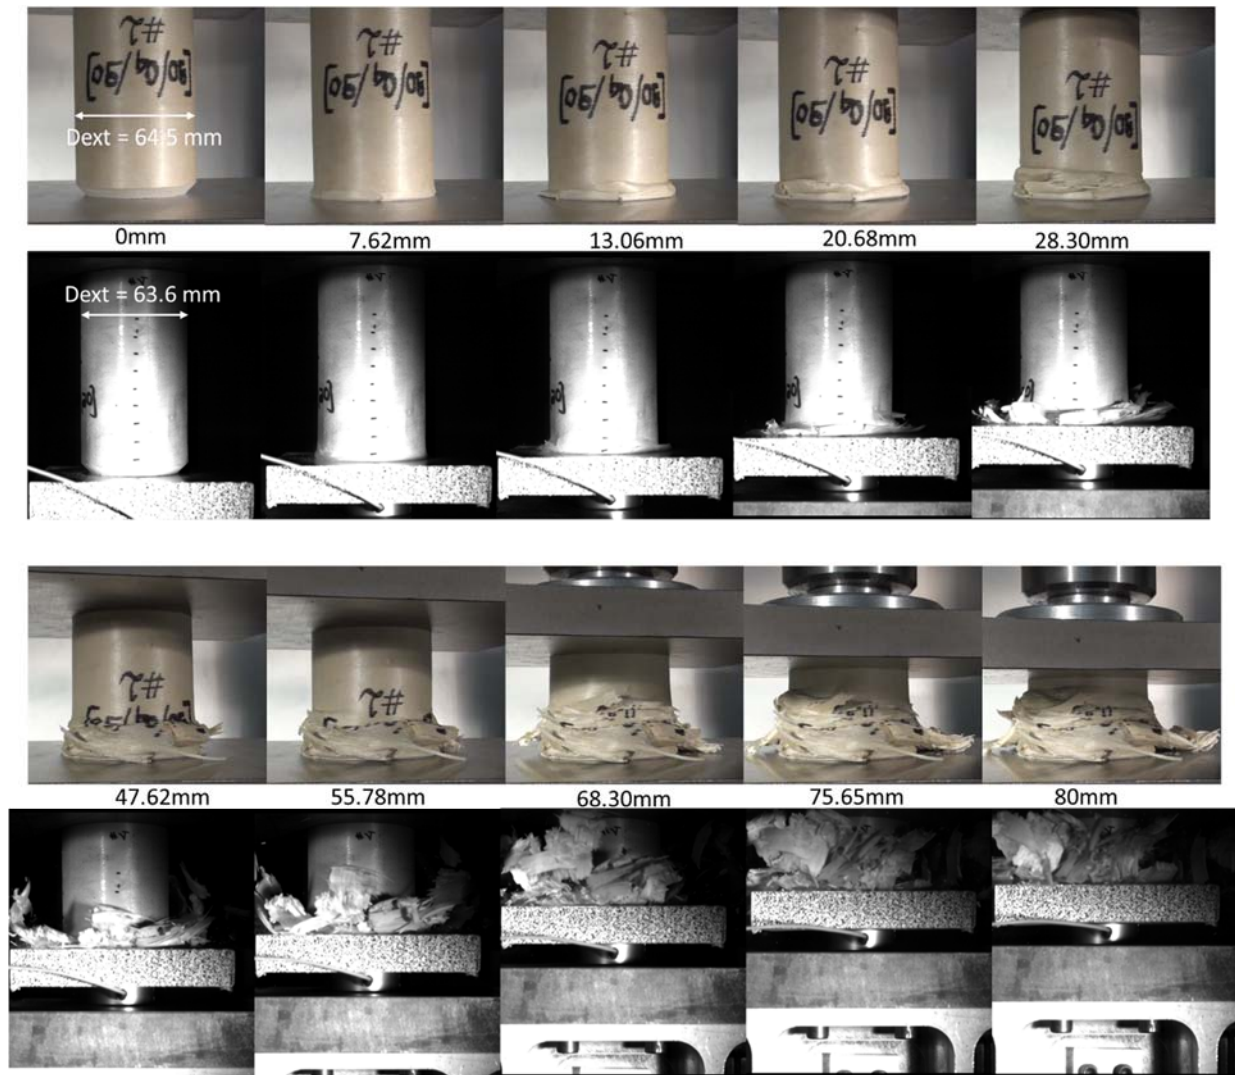
**Fig. 17: Comparison of the failure scenario between a static and a dynamic tests at iso-displacement [90/0<sub>4</sub>/90] - #2 specimen for static – [90/0<sub>4</sub>/90] - #1 specimen for dynamic.**

In this study, the dynamic failure mode differs from the static one. In static, the crushing is stable with creation of folds while the dynamic tubes have a failure initiation identical to the static (formation of a fold) but subsequent propagation is by splaying and fragmentation creating macroscopic and microscopic debris (Fig. 17).
